# UNITED STATES AIR FORCE RESEARCH LABORATORY

Prevention Effectiveness Foreign Object Debris Study (PrE-FOD)

February 1998
Interim Report for the Period August 1997 to February 1998

AFRL-HE-WP-TR-1998-0119

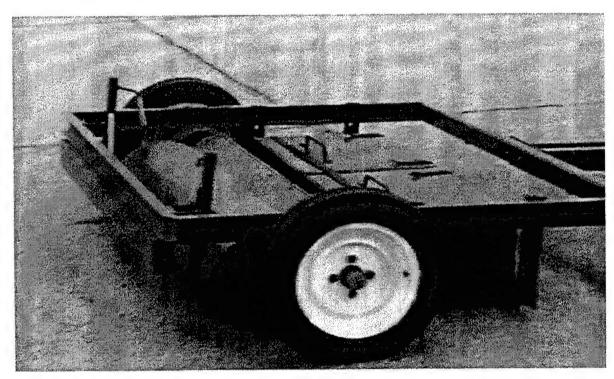
Figure 3. FOD Buster

Relative condition of FOD Buster. When the FOD Buster was received, the heavy rubber used as a ramp for the pickup of the FOD was torn two to three inches at each end. On the second day, the rubber ramp was replaced. However, no evaluations were made on the increase (or decrease) in efficiency of the pick up due to this change.

**Background:** Changing the gearing that rotates the brush mechanism could optimize brush speed efficiency with normal flight line speeds. Currently, in order to pick up FOD effectively, a vehicle towing a FOD Buster must operate at a slightly higher speed than desirable for safe flightline driving around aircraft. A gearing change could alleviate this problem fairly easily. Additionally, a study of the unreliable components in this equipment could result in improved reliability and decreased cost of operation. This could cause the unit to be used more effectively on the flight line.

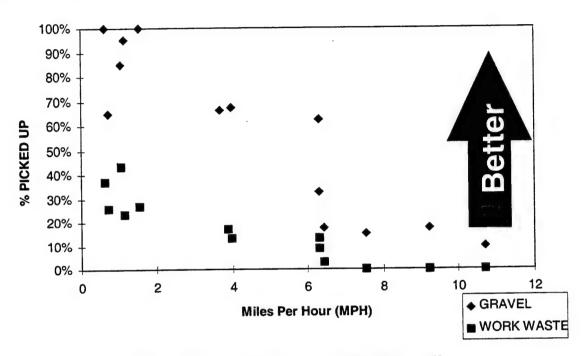
Figure 7. Sweeper Combined FOD Picked Up

During this experiment the sweepers used did not seem to be a very effective way to remove FOD from the test area as show in Figure 7. Debris seemed to blow out the right side of the pickup head, even at two miles an hour or less. When the sweeper was at its most effective, it picked up less than 45% of the work waste. The sweeper seemed to be both the most inefficient FOD retrieval system and by far the least cost effective FOD retriever.

The path the sweeper made through the debris was not nearly as wide as the pick up head. The drivers seemed somewhat shocked at the ineffectiveness of their equipment. When asked to sweep a path through a line of debris, one driver stopped the vehicle over the line in order to insure a path could be seen and evaluated. Although the drivers seemed to think they were cleaning a path six foot across, the actual path width cleared was normally less than three feet. Note: This test is inconclusive because the relative condition of the sweeper being tested was not known. Because of the amount of debris "blown out" of the pickup head, there were some indications of excessive wear, improper adjustments or improper operation. A variable not factored into the sweeper test was the RPM of the auxiliary motor driving the vacuum. It was run at 2000 RPM, which is the correct RPM for flight line sweeping, according to the operators.

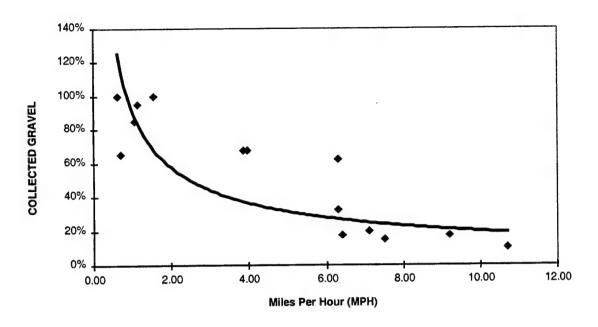
Figure 8. Collected Gravel

The best results for picking up FOD were at extremely slow speeds as noted in Figure 8. The sweeper was almost at a stand still.

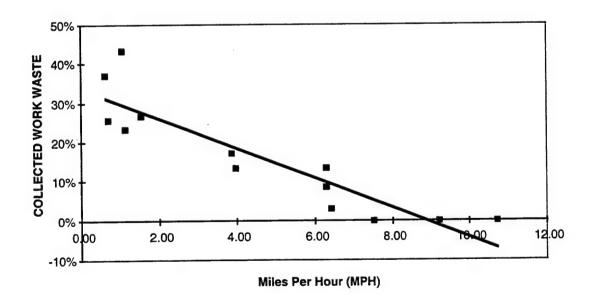
Figure 9. Collected Work Waste

From Figure 3, the sweeper's best results for the collection of work waste were at the slowest speeds.

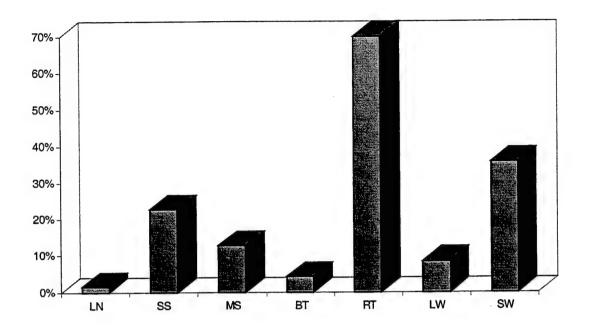
Figure 10. Breakdown of Collected Work Waste

Figure 10 reflects that the lightest work waste (e.g. rivets) usually were picked up. However, the heavier items (e.g. the large bolts, nuts and washers) were either left on the payment or dragged

by the sweeper to outside of the experiment area. The shape of the large nut may also have played a factor in its low retrieval rating.

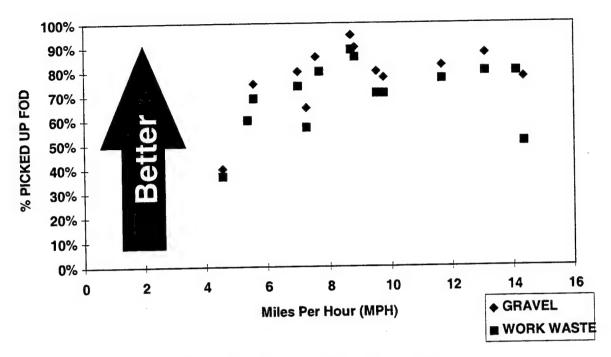
Figure 11. Combined FOD Picked Up

The FOD Buster seemed to be an effective solution for controlling flight line FO, as indicated in Figure 11. Speed of the vehicle towing the FOD Buster was very critical to effective removal of FO. At too slow a speed, FO dams up at the ramp leading to the holding containers. At too high a speed, the debris seemed to be thrown everywhere. Note: The speed the FOD Buster was most effective (7-9 mph) is a little slower than normal flight line traffic speed.

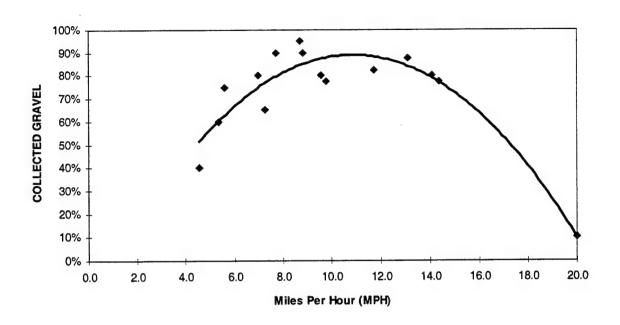
Figure 12. Percentage of Collected Gravel

The best results for the FOD Buster were speeds between 7-9 MPH, as represented in Figure 12. Slower speeds experienced damming while faster speeds threw gravel over the collector containers. Overall collection for gravel was 73%.

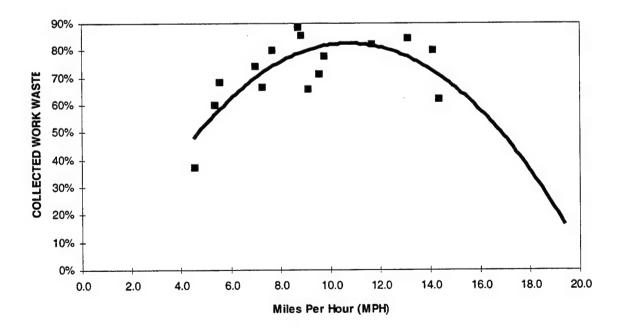
Figure 13. Collected Work Waste

Figure 13 shows that the average work waste collected was 72%. Best results for retrieval of work waste were at speeds between 8-11 MPH.

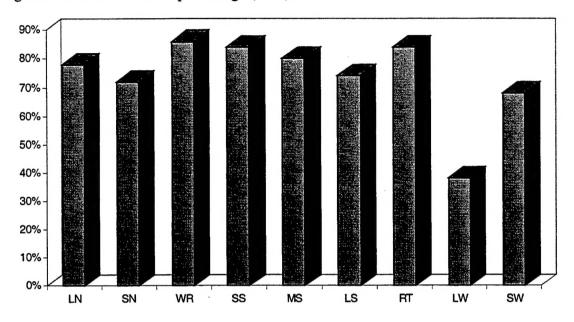
Figure 14. Breakdown of Collected Work Waste

Figure 14 reveals that the FOD Buster collected at least seventy per cent (70%) of all work waste used in the tests except for the large washer. The weight and thickness may have contributed to the large washer's low retrieval percentage (40%).

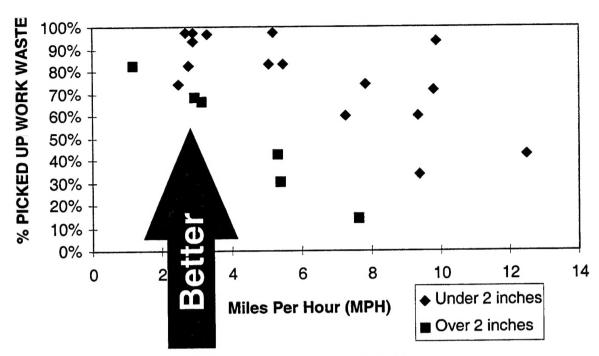
Figure 15. Combined FOD Picked Up

Figure 15 shows that when used at the proper height and speed, the magnetic bar was a very effective tool for collecting metallic debris from the flight line. The lower the bar height and the slower the vehicle, the better the retrieval results. The main problem with the magnetic bar was one of finding a compromise between an effective height for picking up FO versus an effective height that will allow the vehicle to travel on and off the ramp without dragging the bar. When the bar is dragged across any type of surface protrusion, it generally scrapes the FO off the magnet, causing more problems than it is correcting. A secondary problem is the difficulty in removing FO from the bar once it has been picked up. Because of this difficulty, some organizations have let the FOD accumulate on the bar with the potential to cause more FOD migration than it prevented. During the experiment, the buildup of large washers and bolts on the magnetic bar seemed to scatter some of the smaller work waste which prevented the smaller items from being picked up. Vehicle speed was also a factor here.

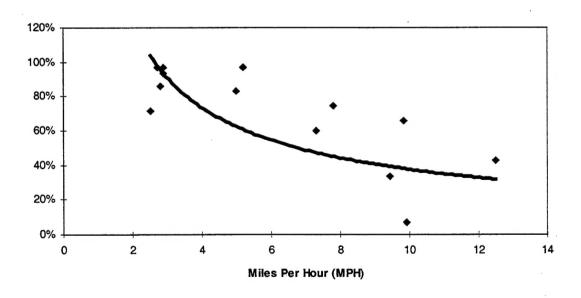
Figure 16. Collected Work Waste

Figure 10 reflects that the best results for collection of the work waste was at extreme slow speeds. For the best results, speeds between 3-6 MPH were the most effective. Collection of work waste had an average of 70%.

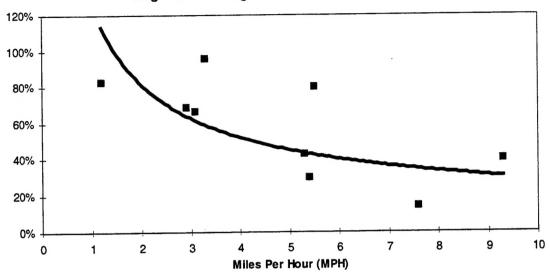
Figure 17. Collected Work Waste

Figure 11 reflects that the best results for collecting work waste with bar heights of one and three-fourth inches and over is at very slow speeds. Best speed results were 3-5 MPH with 58% collected overall.

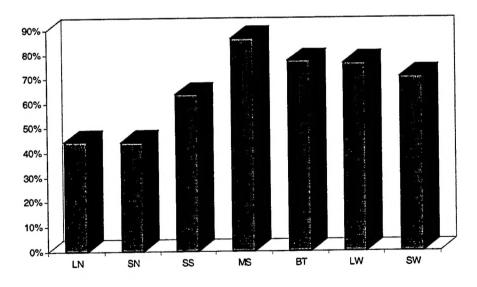
Figure 18. Breakdown of Collected Work Waste

Figure 18 shows the breakout of collected work waste. The shape of the large and small nuts along with their metallic content may have played a factor in the retrieval of these items. In addition, the small screw's metallic content may have also contributed to its low retrieval percentage.
